Volume 2

X. Managing Watershed Sediment

TABLE OF CONTENTS

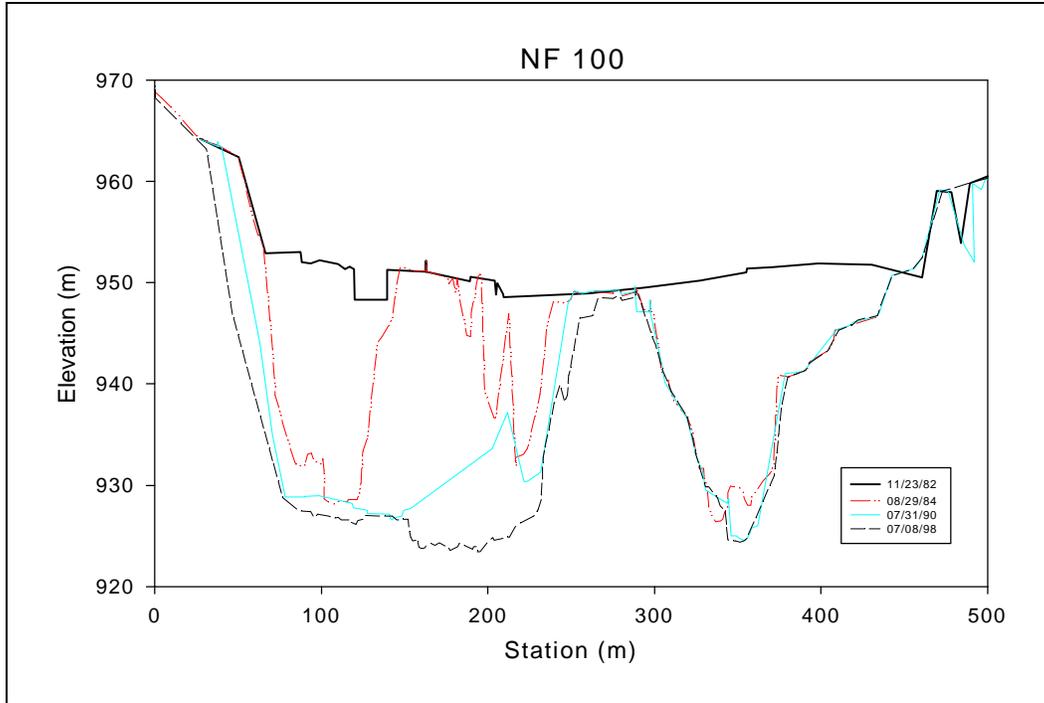
Figure 1 Typical cross section data for the North Fork Toutle River.

Historic cross section survey information was evaluated to identify trends in channel cross section development such as channel widening and channel degradation. The rate at which channel cross section development has occurred and whether or not the channel has stabilized was assessed. Surveyed cross sections (USGS, 2000) along the North Fork Toutle, South Fork Toutle, and Toutle Rivers were utilized in the analysis. Cross sections have been repeatedly surveyed at more than 100 locations along these three rivers. Cross section surveys began as early as 1980, and have been resurveyed periodically up through 1999. Typical results are shown in Figure 1. Cross sections on the North Fork Toutle, South Fork Toutle, and Toutle Rivers show a general trend of increased cross sectional area since the eruption. A majority of the cross sections have had a significant amount of streambank erosion and channel degradation. As a result, many locations show an increase in channel width and lowering of the thalweg elevation

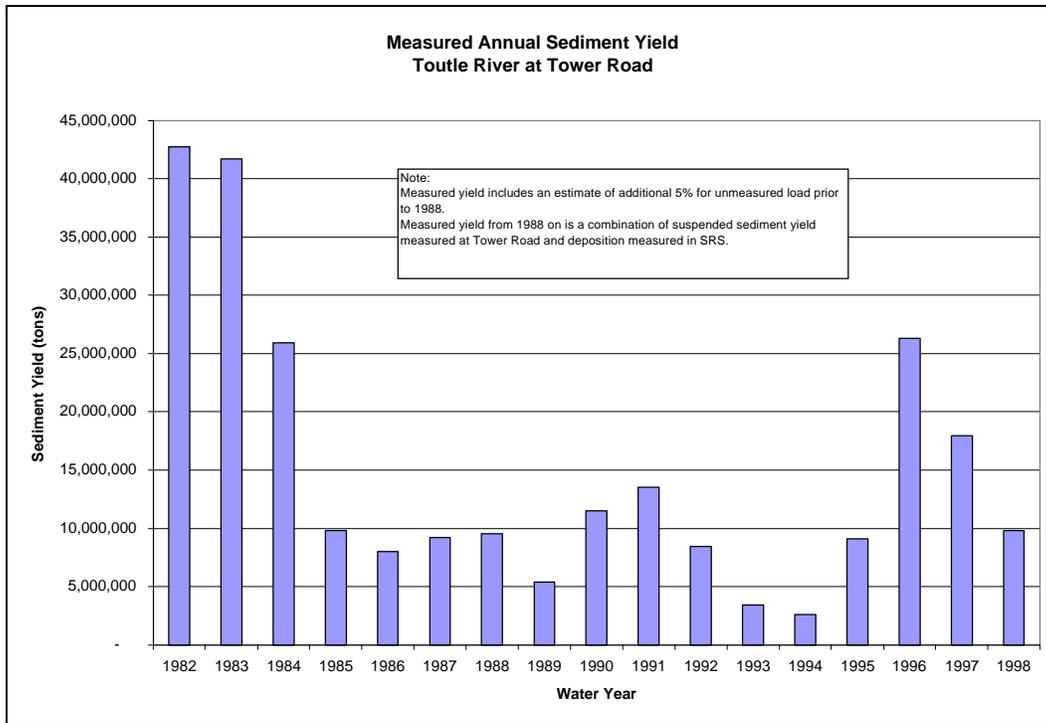
Figure 2. Measured annual sediment yield from Toutle River at Tower Road.

As seen in Figure 2, annual sediment yields measured at Tower Road were significantly large during the early 1980's, but then reduced fairly rapidly throughout the late 1980's and early 1990's. This would indicate that recovery in the watershed was causing a reduction in sediment supply to downstream areas. However, this time period was also a period of below average runoff. Total annual runoff was approximately 15 percent below normal for the period 1985 to 1995. A significant increase in sediment yield occurred during the 1996 and 1997 water years as total annual runoff was approximately 45 percent above normal. This would indicate that sediment yield from the watershed is highly dependent upon the hydrology. Variability in the hydrologic cycle would tend to mask trends in the reduction of sediment yield. However, the fact that the sediment yields measured for 1996 and 1997, the largest water years of record, were less than those measured in 1982 and 1983 would indicate that some recovery has taken place. However, the sediment yield in 1996 was nearly the same as occurred in 1984, which further indicate the dependence of sediment yield on the involved hydrology. To account for the dependence between sediment yield and hydrology, the annual sediment yield was divided by the annual runoff to determine the yield of sediment per unit volume of runoff or average sediment concentration. As seen in Figure 3, the yield of sediment in 1996 was approximately 11.7 tons per acre-ft of runoff while the yield in 1984 was approximately 15.3 tons per acre-ft of runoff, a reduction of approximately 24 percent, providing further evidence of watershed recovery.

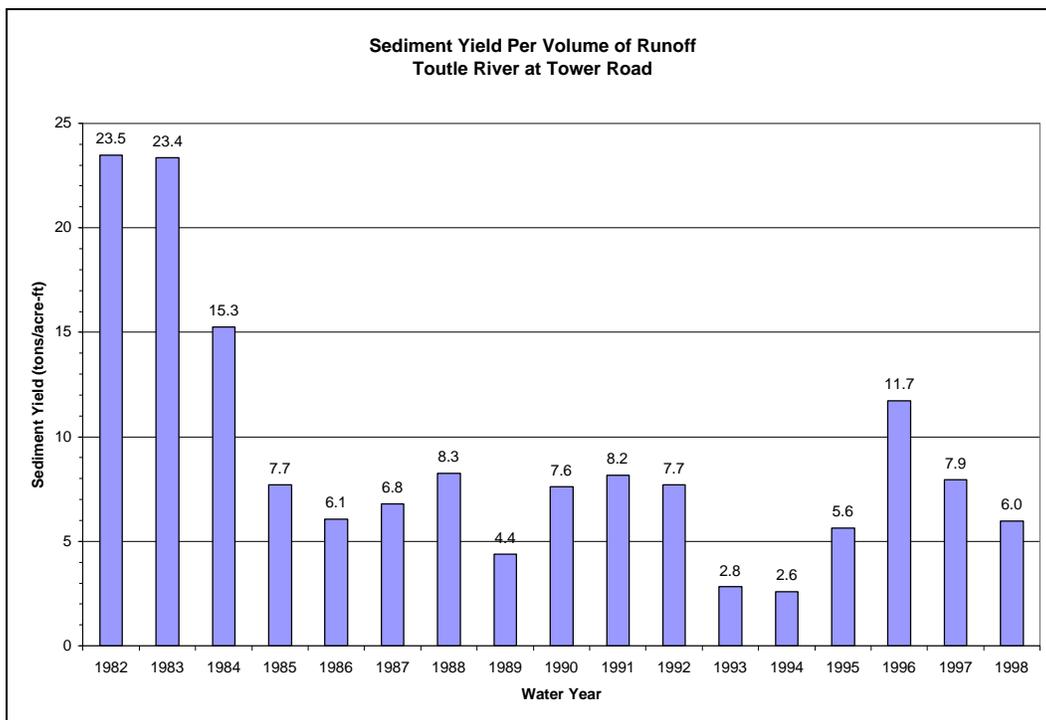
Figure 3. Annual sediment yield per unit volume of runoff.

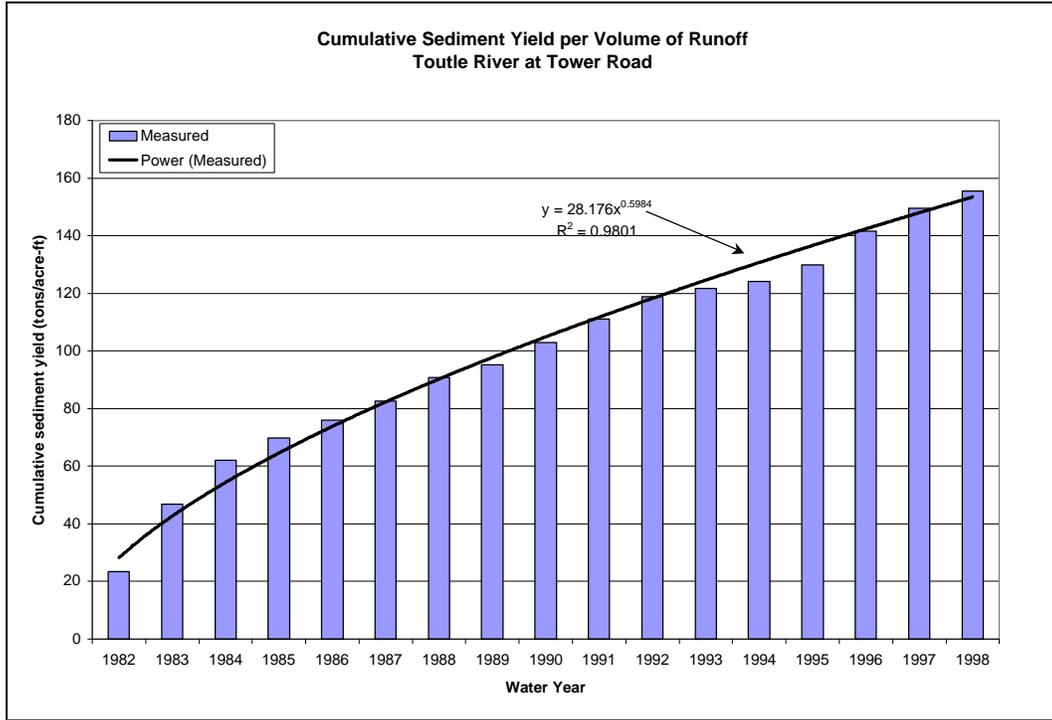
Figure 4. Cumulative sediment yield per unit volume of runoff.

Figure 4). A trend line was fit to the cumulative concentration data to develop a sediment concentration decay curve. This decay curve was then extended to the end of the MSH Project planning period to estimate the reduction in average annual sediment concentration that might be expected to occur by the year 2035. The predicted annual sediment concentrations were multiplied by the average annual runoff volume to estimate the annual yield of sediment from the debris avalanche. Figure 5 shows that over the next 35 years, the annual sediment yield would reduce by 2.3 million cubic yards or approximately 36 percent. It is noted that this estimate is based upon average hydrologic conditions that have occurred between 1931 and 1998. Future hydrologic conditions that differ from those considered in the analysis as well as significant vegetative recovery in the watershed or future volcanic eruptions would significantly alter the estimated rate of reduction in sediment yield.

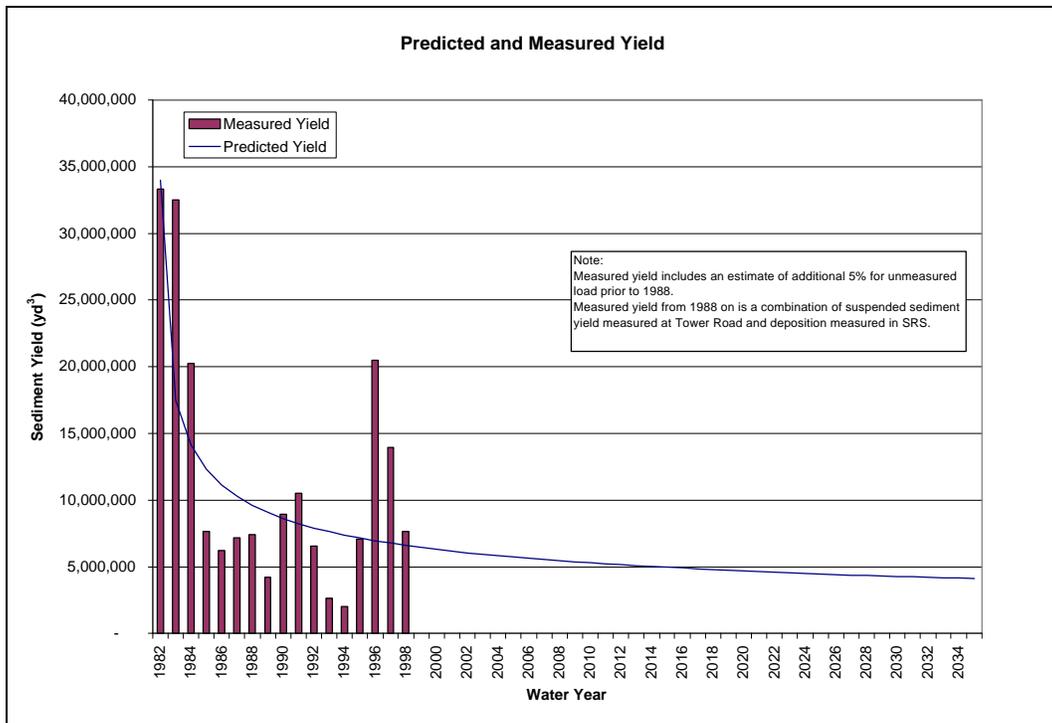
Figure 5. Predicted and measured sediment yield.

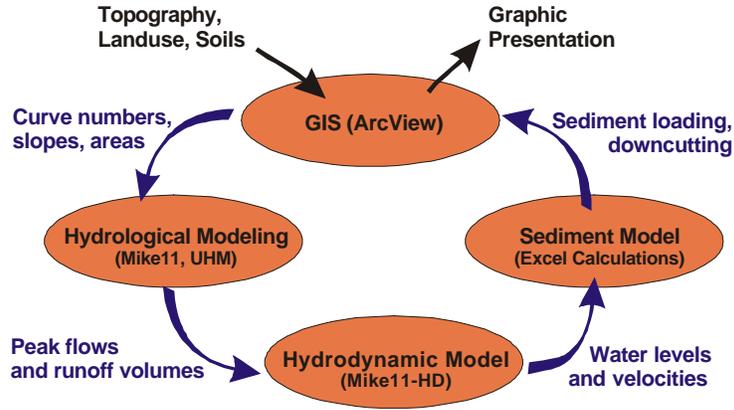
Figure 1. Nemadji Sediment Transport Model System

Description of the Model System: The modeling system consists of GIS-database components, a hydrologic model, a river hydrodynamic model and a sediment transport model as shown in Figure 1. ArcView GIS is used to create geographic data, analyze the data, and prepare the data for input to the hydrologic model and the hydrodynamic model. The hydrologic model generates time-series runoff for input to the river hydrodynamic model. The hydrodynamic model provided the hydrodynamic parameters such as water velocity, depth and discharge to the sediment transport model. Lastly, the sediment transport model predicts sediment erosion and deposition in the river. Based on a review of a range of options for the three key model components, the Danish Hydraulic Institute (DHI) MIKE system was chosen for the hydrological model and hydrodynamic model. A customized sediment transport model was developed because the

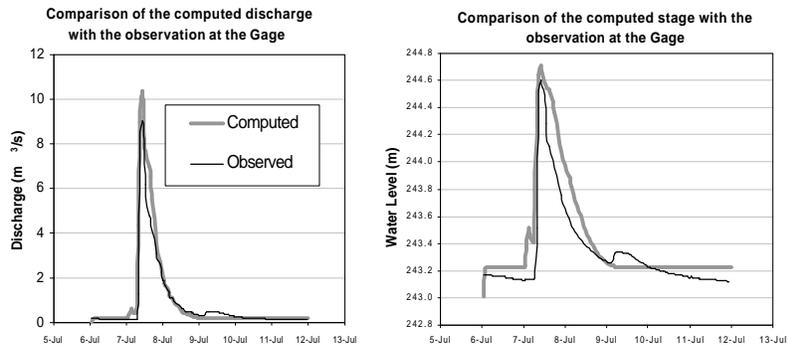
Figure 2. Verification of the Rainfall/Runoff Component

The Rainfall/Runoff model calibrations are carried out to verify the aggregated Curve Number (CN) calculated in the GIS component and the estimated lag time. The CN value is a main parameter influencing the excess rainfall which should be equal to total runoff in a single storm event. The lag time is another key parameter that distributes the excess rainfall in time and influences the duration of the runoff period. Both parameters are adjusted according to calibration results.

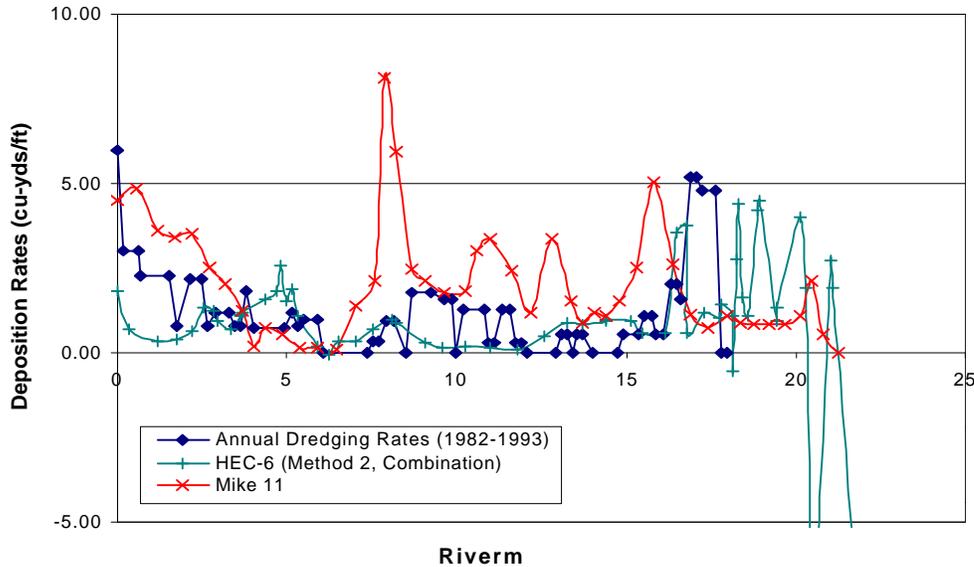
Figure 6. Comparison of deposition rates computed by HEC-6 and MIKE 11 to the dredging rate

To demonstrate the difference between the unsteady model, MIKE 11, and the variable steady model, HEC-6, the sediment deposition rates along the river computed by both models are compared with the average annual dredging rate and shown in Figure 6. River Mile 0 coincides with the river mouth at the downstream end of the model domain. The HEC-6 result shown in Figure 10 is computed using Method 1 for clay and silt transport and the Combination equation for sand transport. The HEC-6 model underpredicts the sediment deposition in the downstream section of the river near the mouth. This may be induced by the steady hydraulic calculating scheme, which may not account for the flow speed reduction at the mouth resulting in increased deposition. In contrast, the hydrodynamic model, MIKE 11, reproduces the physical process of sediment deposition near river mouth reasonably well.

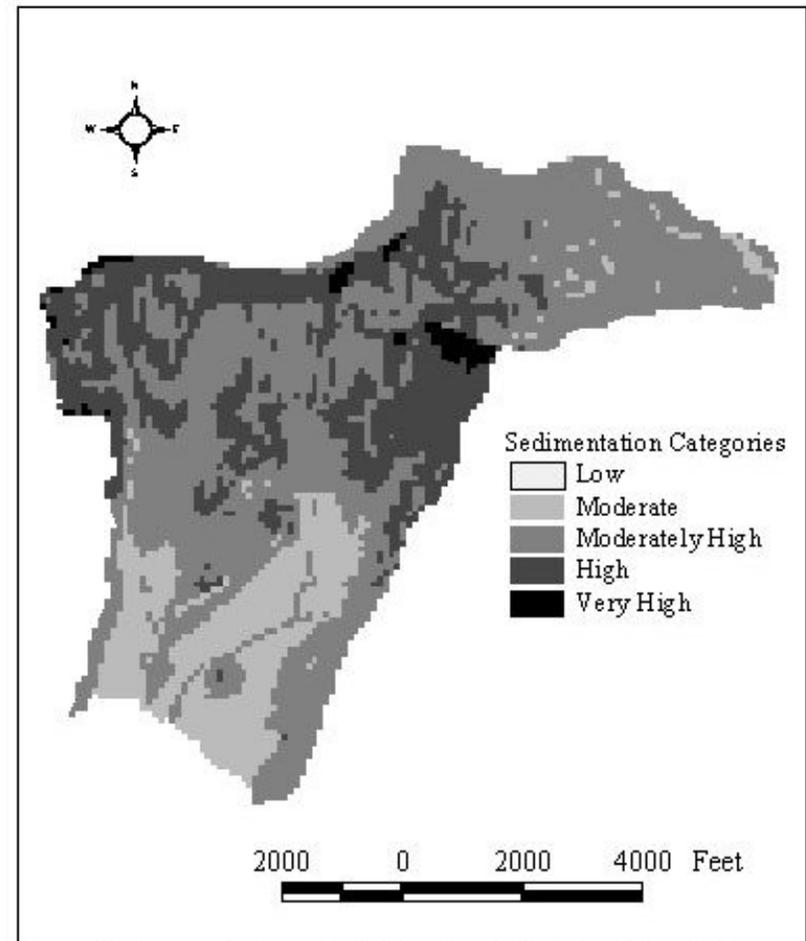
Figure 2. General sediment yield rates obtained with the GIS model, Santa Cruz watershed.

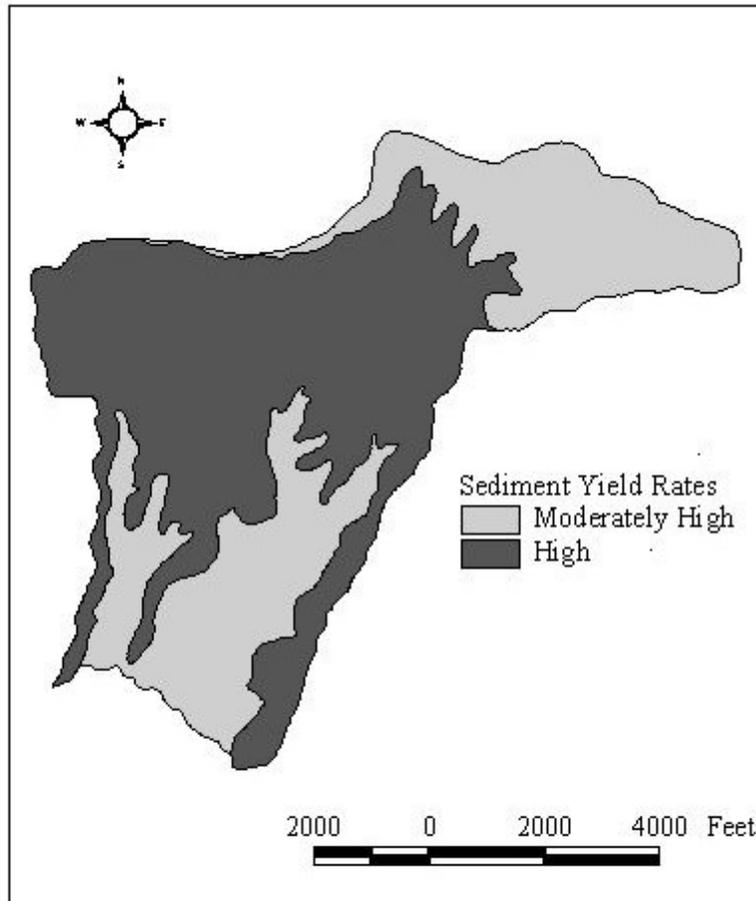
Figure 3. General sediment yield rates obtained in the conventional manner, Santa Cruz watershed.

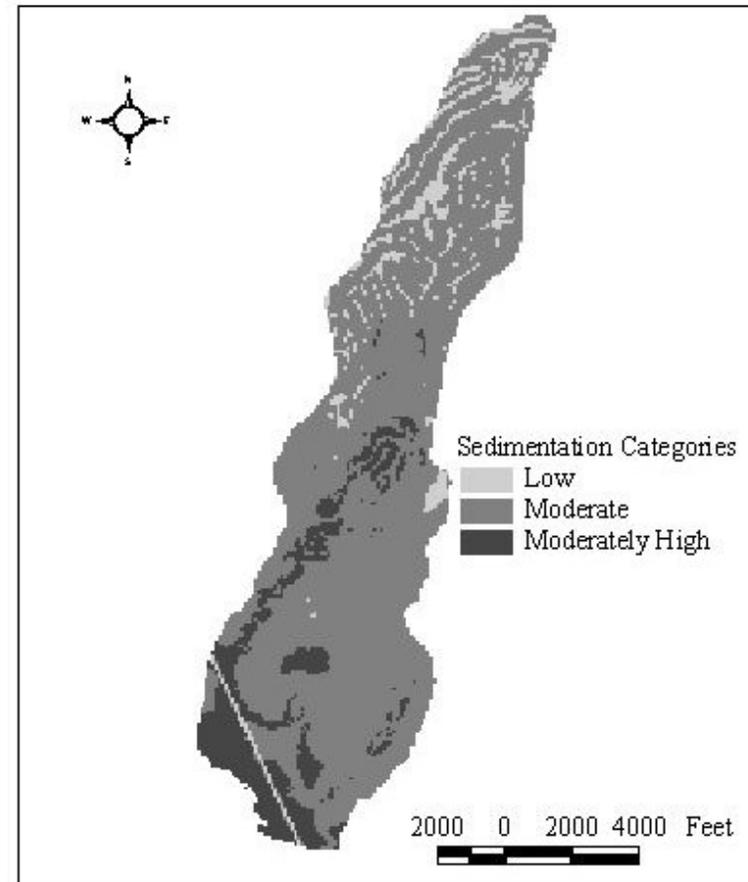
Figure 6. General sediment yield rates obtained with the GIS model, Hatch Valley watershed.

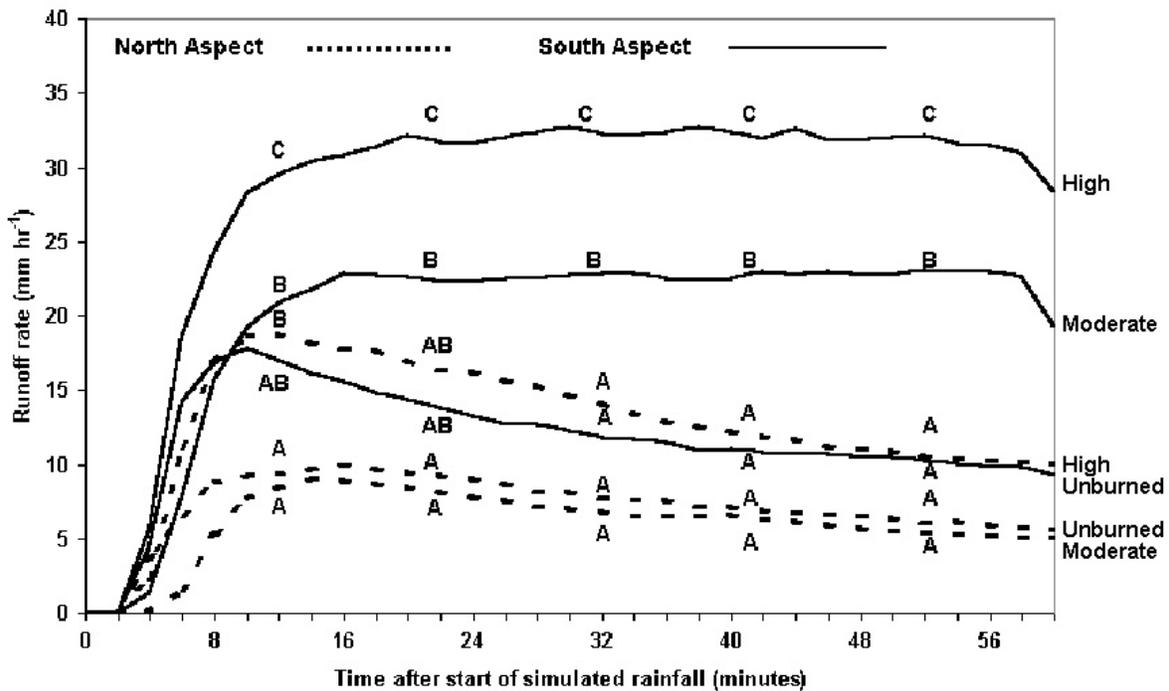
Figure 1. Runoff rate over time for burned (high and moderate fire intensity) and unburned, north and south slopes, Eighth Street Fire, Boise Front, Idaho. Means for each time period with a different letter are significantly different ($P \leq 0.05$).

Fire intensity had the greatest impact on runoff on the south slopes (Figure 1). Intensively burned south-facing slopes had the lowest cumulative infiltration (34.2 mm) followed by the moderately burned south slopes (46.2 mm), compared to the unburned south slopes (58.0 mm). This represents nearly a two-fold increase in runoff produced by the fire. Fire intensity also produced significantly greater erosion from south aspects as well (Figure 2). Cumulative erosion was up to 34 times higher on intensively burned south slopes compared to unburned conditions or even burned north aspects. This was due to the devastating removal of nearly all the vegetative ground cover that protects the soil and much of the soil organic matter that helps to bind soil particles together.

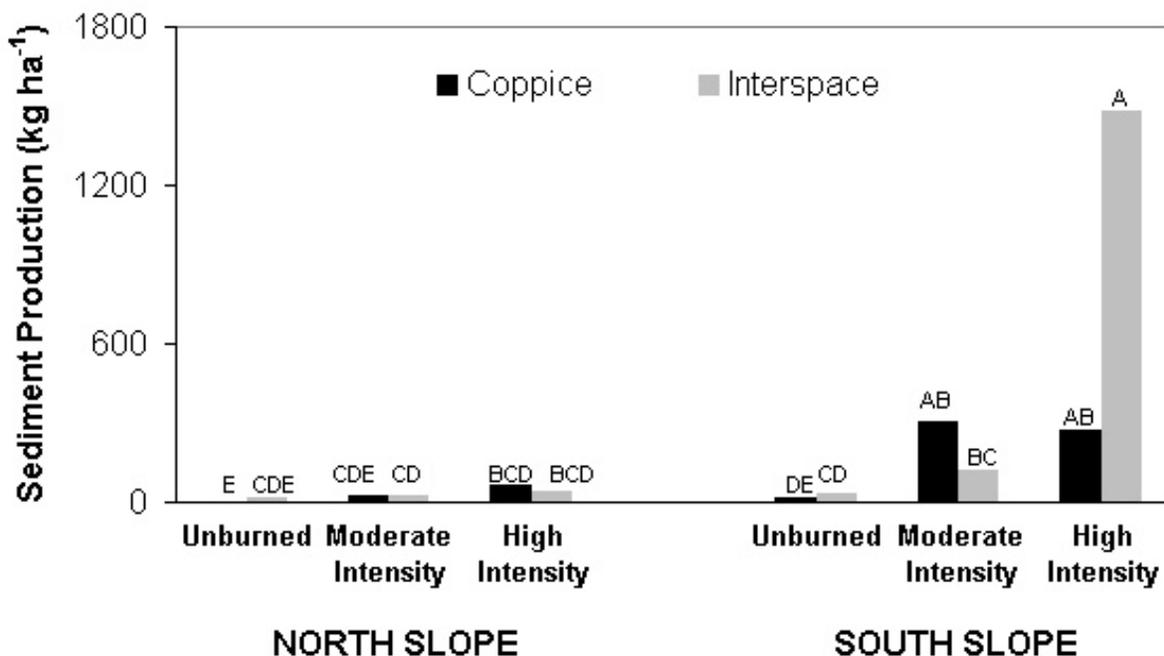
Figure 2. Average total sediment yield (kg ha⁻¹) for burned (high and moderate fire intensity) and unburned coppice and interspace areas on north and south slopes, Eighth Street Fire, Boise Front, Idaho. Means across aspect and fire intensity with a different letter are significantly different ($P < 0.05$).

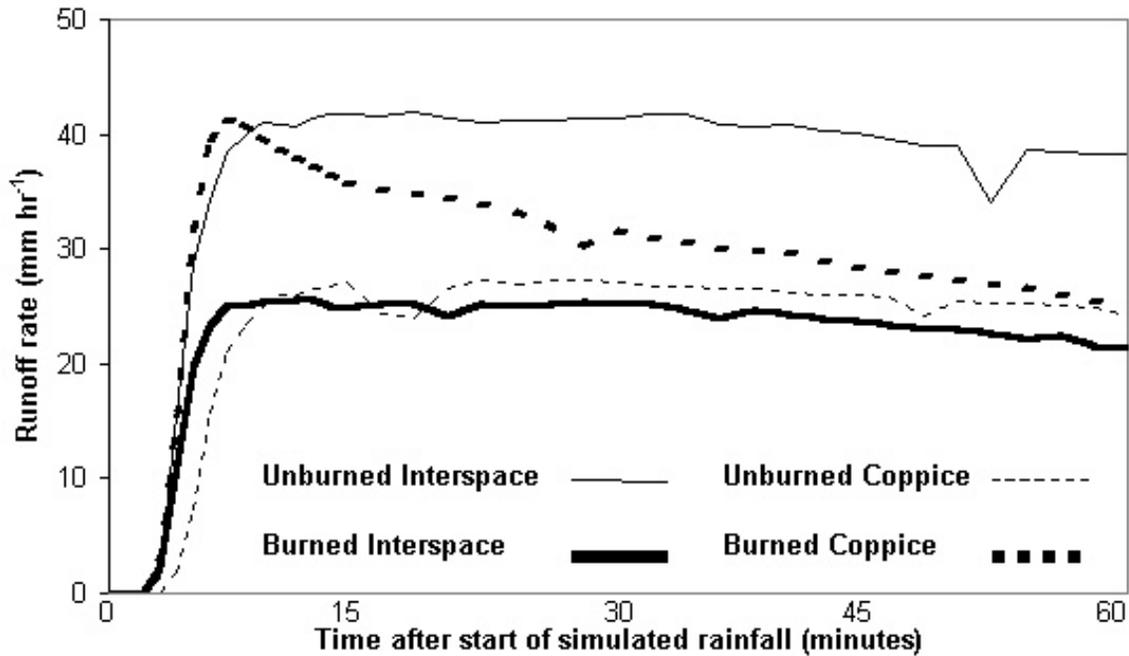
Figure 3. Runoff rate over time for burned and unburned coppice and interspace areas, Denio Fire, Pine Forest Range, Nevada.

All burned and unburned sites showed a rapid runoff response with overland flow beginning within 0-4 minutes after initiation of rainfall (85 mm hr⁻¹) (Figure 3). This result is consistent with the rapid hydrologic response measured on the Boise Front. Runoff from all unburned sites showed greater initial runoff from interspace areas compared to coppices, consistent with findings from other studies of the effects of coppice areas on infiltration processes (Pierson et al. 1994). In contrast, runoff from burned sites all had greater initial runoff from coppices that gradually decreased throughout the rainfall period

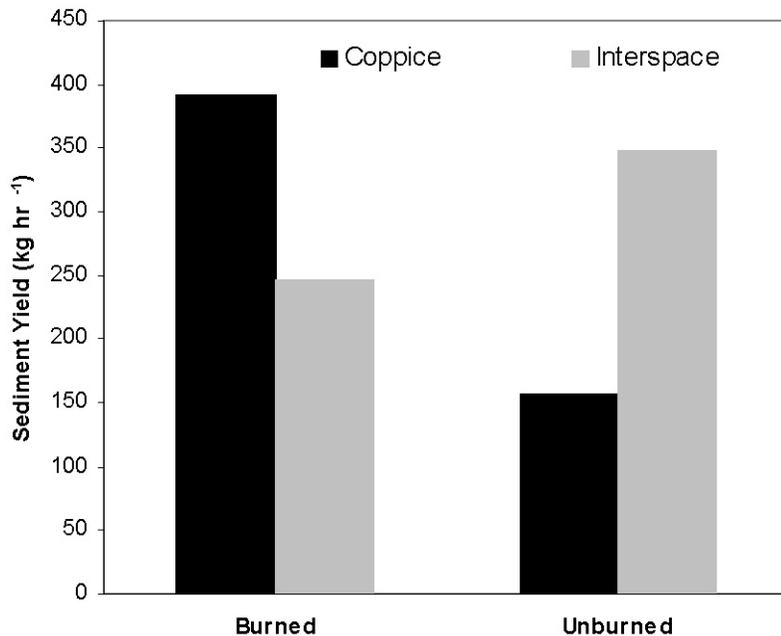
Figure 4. Average sediment yield for burned and unburned coppice and interspace areas, Denio Fire, Pine Forest Range, Nevada.

(Figure 3). In addition, fire had the greatest impact on erosion from burned coppices as well (Figure 4). However, the fire impacts on infiltration and erosion were relatively small, but do indicate that fire can produce a hydrophobic condition on the densely vegetated coppices whereby infiltration is decreased and soil erodibility is increased.

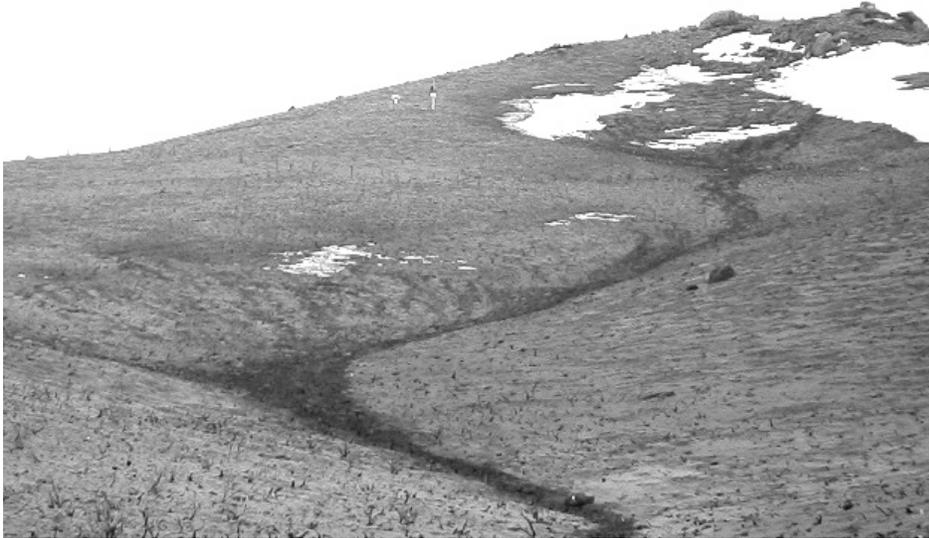
Figure 5. Photo of rill erosion during period of rapid snowmelt in late March following the Denio Fire, Pine Forest Range, Nevada.

Significant rilling was observed on the burned Denio study sites following periods of rapid snowmelt during the first winter following fire (Figure 5). No rills were observed on the unburned sites. Measurements of rill erosion were then initiated, but results have not yet been summarized. However, very strong differences were observed in overland flow characteristics and rill formation between burned and unburned areas (Figure 6). While fire may not significantly affect infiltration and interrill erosion in these sagebrush/grass ecosystems, it may have a profound effect on concentrated flow paths and rill erosion processes.

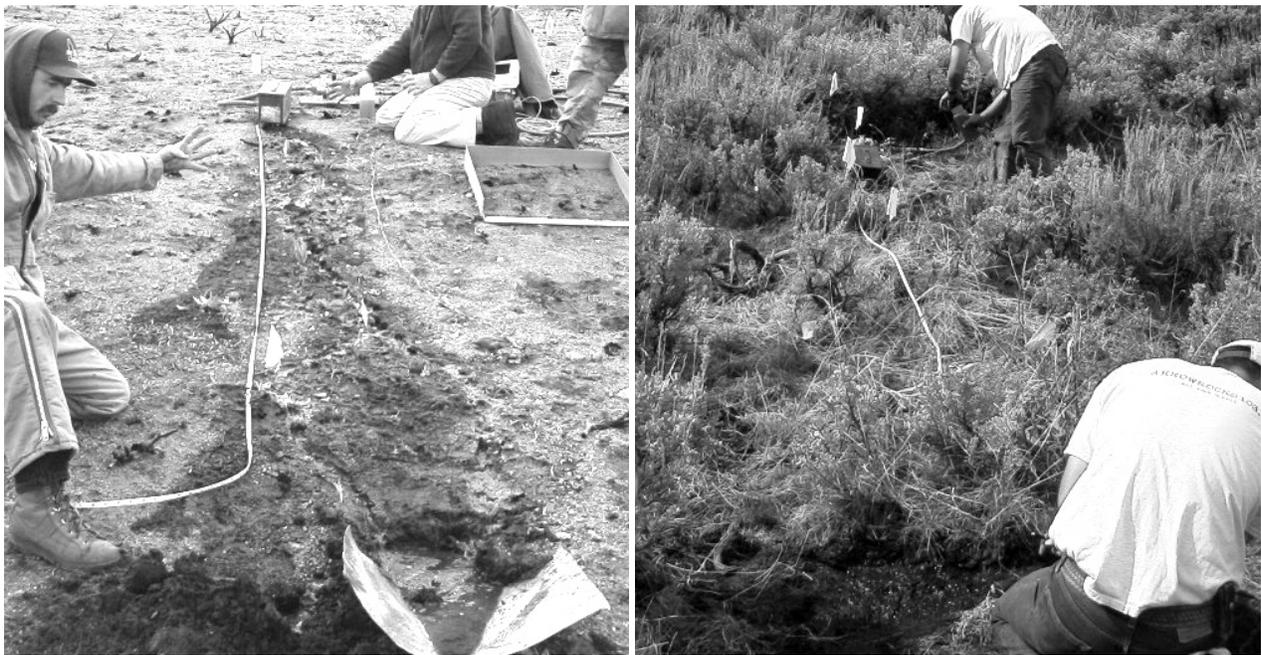
Figure 6. Contrasting photos of concentrated flow and subsequent rill formation between intensely burned areas on the Denio Fire and adjacent unburned areas, Pine Forest Range, Nevada.

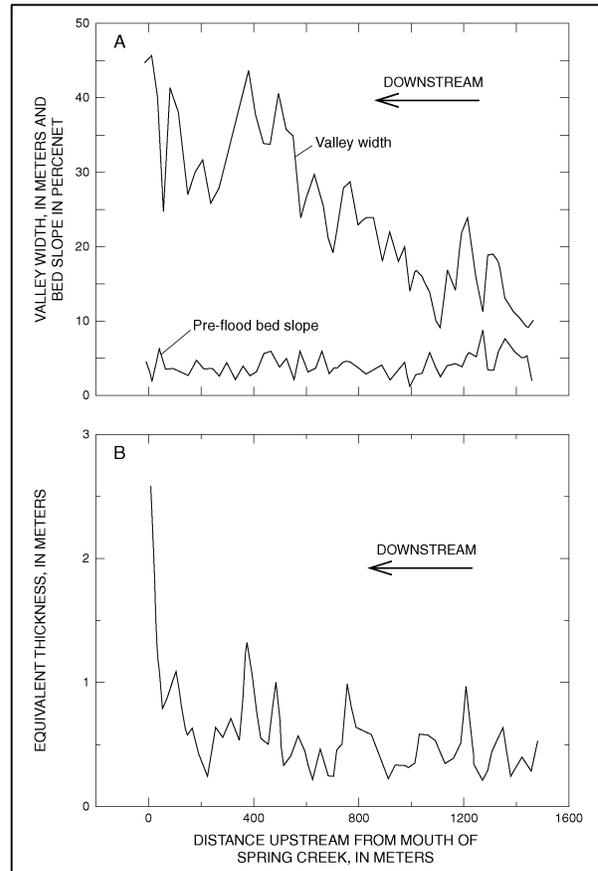
Figure 2. Initial morphology of the superslug created by severe erosion after a wildfire. A. Valley widths were measured in 1997 and the bed slopes (before the flash flood on 12 July 1996) were measured approximately every 30 m from 1:12000 aerial photographs. B. Equivalent thickness of sediment is the thickness in a uniform channel 27 m wide. Sediment deposited after the flood was measured as the difference in elevations between pre- and post-flood aerial photographs.

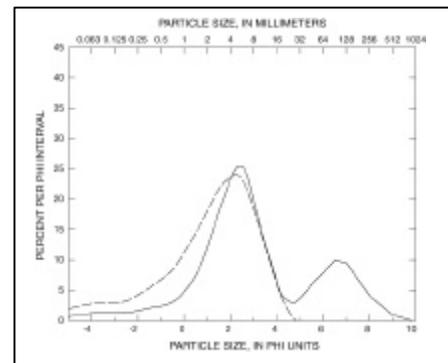
Figure 3. Particle-size distribution of the hillslope source of sediment (dashed line) and the channel bed material (solid line) composing the superslug. The median diameters of the hillslope source, the surficial sediment in the bed material, and the bank material in the bed material are 2.8 ± 0.4 , 4.6 ± 2.7 , and 110 ± 3.2 mm respectively.

Particle-Size Bed material composing the superslug had a bimodal distribution with components from the hillslopes and from the pre-flood channel banks. Particle-size distribution of the hillslope sources had a median diameter of 2.8 mm, a dispersion of 4.6, and was similar to the particle-size distribution of the surficial sediment of the superslug (Figure 3). Characteristics of surficial sediment varied from upstream to downstream and indicated that some sorting had occurred. At about 5000 m upstream from the mouth of Spring Creek, the median diameter of the surficial sediment was about 2.5 mm and was consequently better sorted (dispersion = 3.4) than the hillslope sources. The median diameter increased downstream and was about 4.4 mm (dispersion = 2.9) at the mouth.

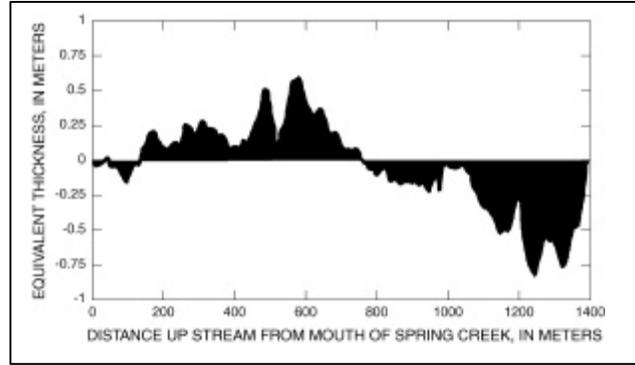
Figure 4. Equivalent thickness of eroded (negative) and deposited (positive) sediment in the main channel of Spring Creek between October 1997 and May 1998 (see figure 6, time interval 6).

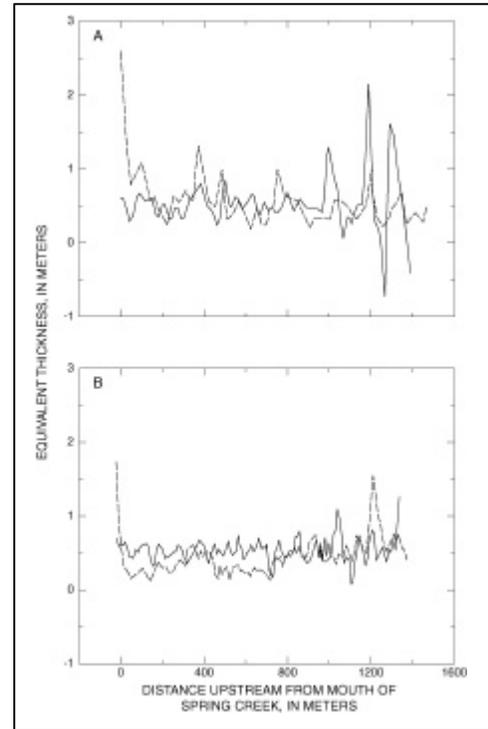
Figure 5. Analytical model for net erosion and deposition as a result of a flash flood. A. The measured equivalent thickness (dashed line) for the 12 July 1996 flash flood (see figure 2 and figure 6, time interval 1) is compared to the predicted thickness (solid line). The proportionality constant C was set arbitrarily to 10 to produce similar amplitudes and an offset of 0.5 m was applied. B. The measured equivalent thickness (dashed line) for the 31 August 1997 flash flood (see also Figure 6, time interval 4) is compared to the predicted thickness (solid line) where the proportionality constant C was set arbitrarily to 10 to produce similar amplitudes and an offset of 0.5 m was applied.

wider reaches where willows and cottonwood trees were more numerous than in the narrower reaches. This analytical model assumes a constant roughness, and if the roughness in the narrow reach between 1000 and 1400 m was reduced there would be a decrease in the predicted thickness and an improvement in the prediction by the model. Differences between the measured and predicted deposition is also large near the mouth of Spring Creek at the junction with the South Platte River where the channel conditions change abruptly. Actual deposition was probably controlled by the water level in the South Platte River which created an effective slope that was possibly much smaller than the slope in the Spring Creek channel upstream from the mouth used in the model. This simple model was also applied to the deposition from the 31 August 1997 flash flood (Figure 5B) and once again reproduced the general spatial pattern of deposition which for this flood was measured at about 10 m intervals. The best predictions of deposition, however, were achieved when the bed slope was spatially averaged over 3 reaches (about 30 m) producing “regional” slopes similar to those used for the initial flood in 1996. In addition, the differences in the measured and predicted thickness were less when differences between sediment transport were computed over 3 reaches (~30 m) or approximately the valley width. Deposition seems to be controlled by a “regional” slope averaged over the distance of several reaches upstream. This distance was larger (~ 90 m) for the 12 July 1996 flash flood (estimated peak discharge of $510 \text{ m}^3\text{s}^{-1}$) than the distance (~30 m) for the 31 August 1997 flood (estimated peak discharge of $180 \text{ m}^3\text{s}^{-1}$).

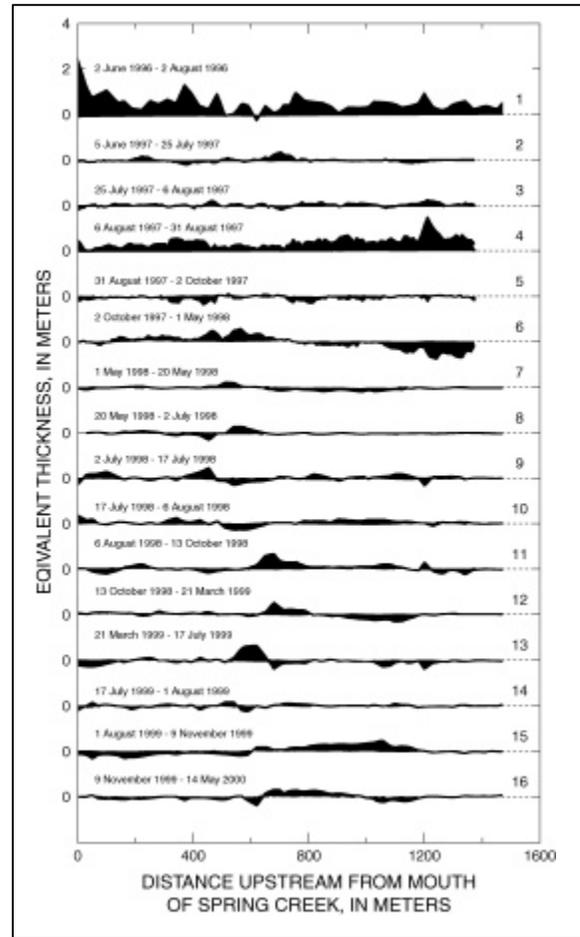
Figure 6. Changes in the morphology of the superslug within the study reach. The changes in equivalent thickness between successive surveys of the study reach are shown with time increasing downward. The time intervals are not equal but represent 16 measurements of change over the four years following the wildfire and initial erosional and depositional event.

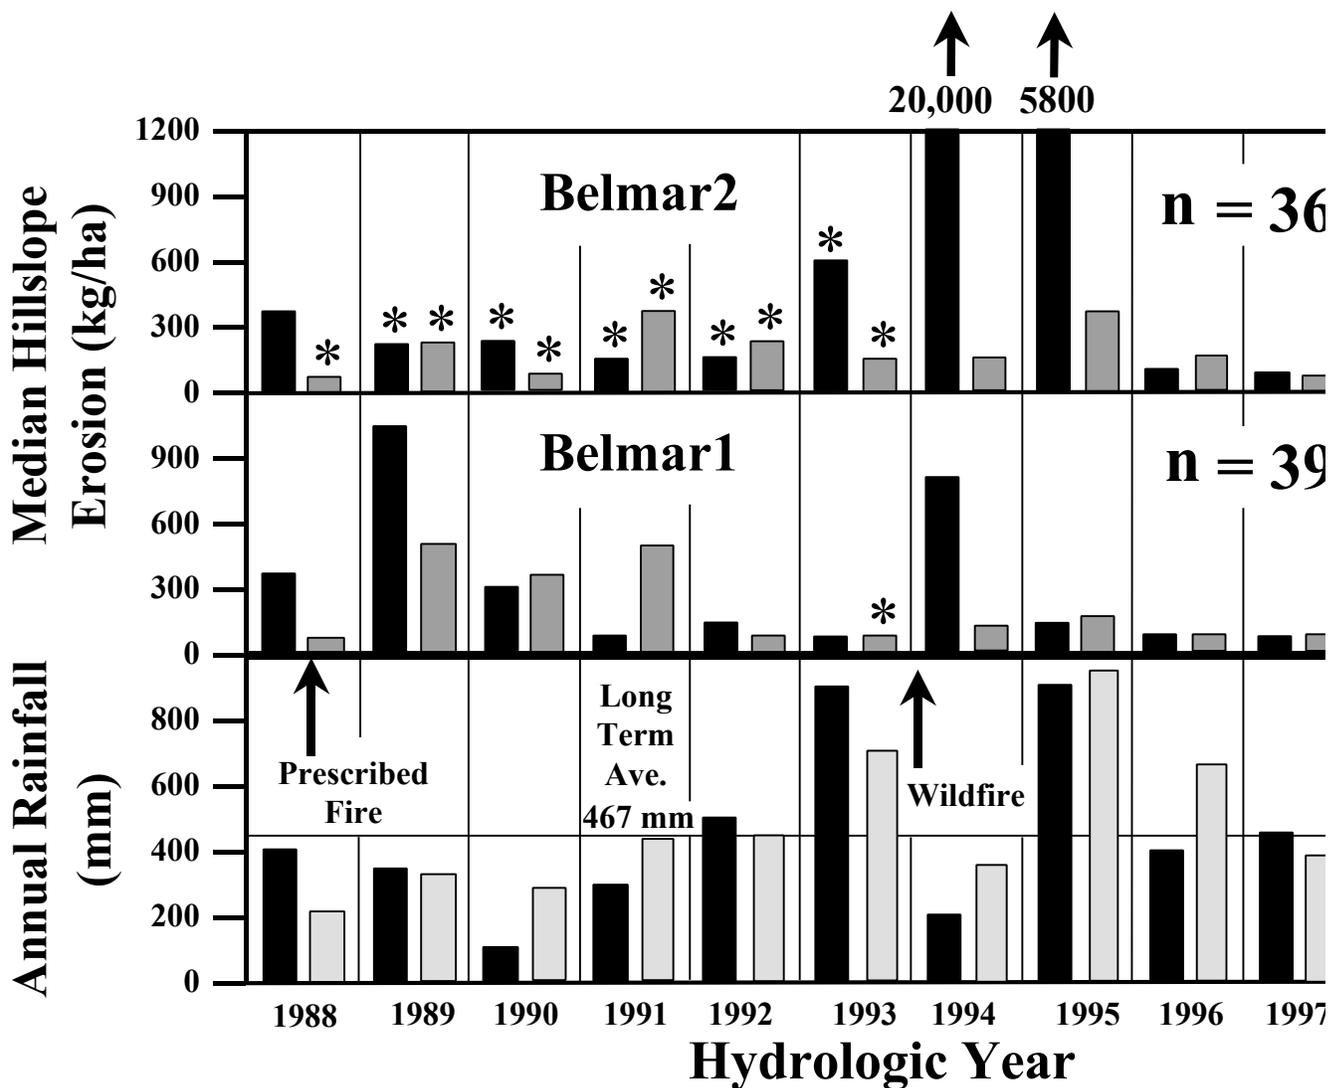
Figure 2. Hillslope erosion and rainfall at the Belmar sites by hydrologic year (October 1 to September 30). The up season erosion; the patterned histograms are dry season erosion. Histogram widths are standardized and do not represent actual values. Asterisks (*) are estimated values (see text). Sample size for the winter/spring 1988 preburn collection was 22 and 24 for the Belmar1 and Belmar2 respectively. Sample size for the estimated Belmar2 preburn period was 24. The lower black histograms are annual rainfall intensity.

The short-interval reburn produced only moderate erosion initially and very minor erosion during the subsequent years. This probably reflects the patterns of vegetation regrowth, as the herbaceous cover was 2-3 times greater after the reburn than after either the prescribed fire or the wildfire (Beyers and others 1998). Presumably, the seed bank from the herbaceous plant community following the prescribed fire sprouted vigorously after thereburn, and the additional cover afforded greater site protection against postfire erosion, even in a very wet year. This would explain the results of the foregoing statistical analyses, and would account for the lower levels of erosion after the

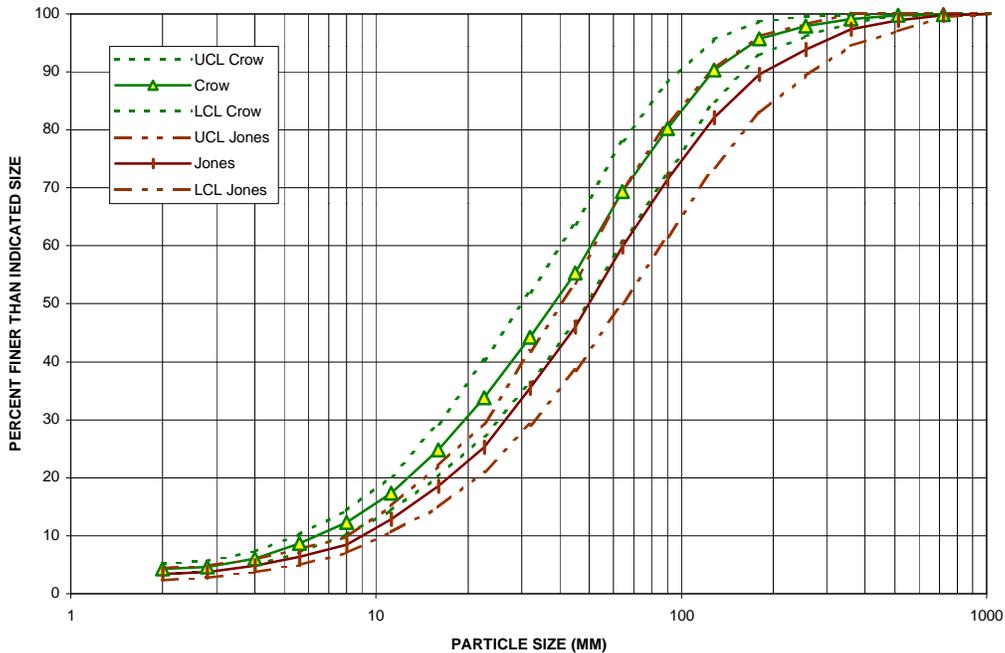
Figure 2 -- Mean grain-size distributions on riffles of 20 low-gradient reaches (UCL and LCL are upper and lower limit, respectively, of 90-percent confidence interval).

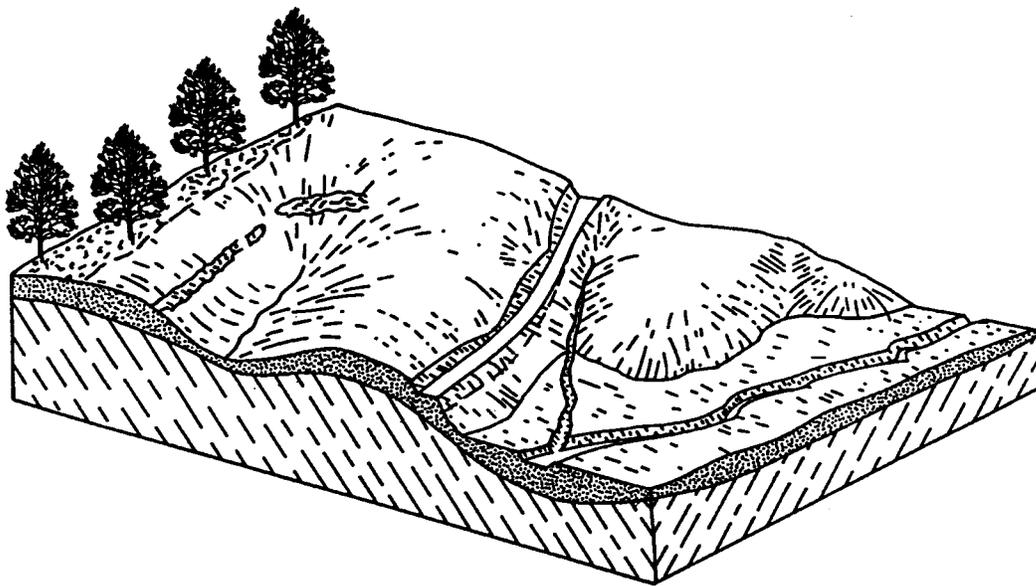
Figure 1: Landscape Zone Profile

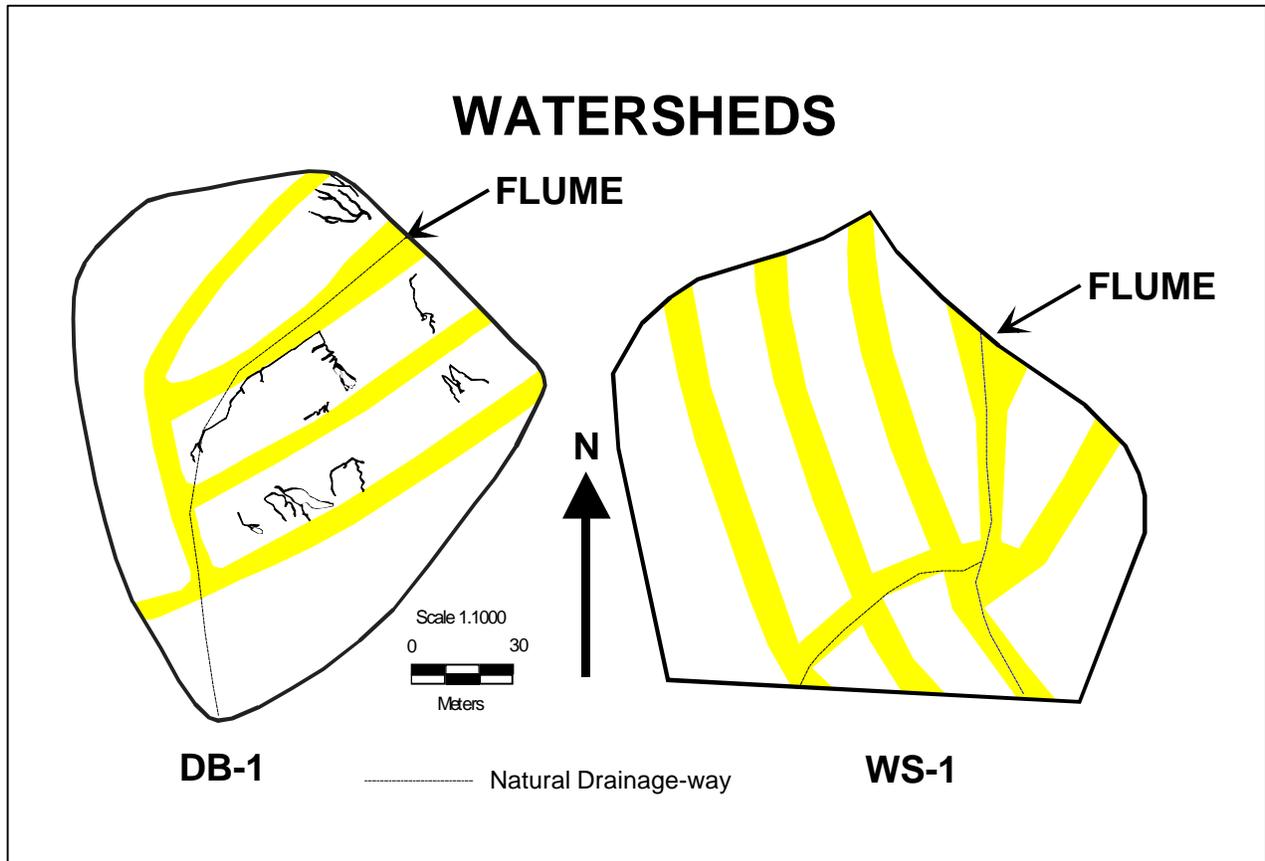
Figure 1. Layout of 6.1 m wide grassed buffer strips on the DB-1 and WS-1 watersheds. Crops were planted between the grassed buffer strips. Rills and small gullies developed in the fourth year after the fourth year of continuous no-till cotton are shown in the DB-1 watershed sketch. A corn -cotton rotation was grown on the WS-1 watershed.
